Extra Service/Repair/Upgrade :

This is separate and additional to the scheduled normal servicing – records of this are also kept.

OWNER: Brendan Cunningham

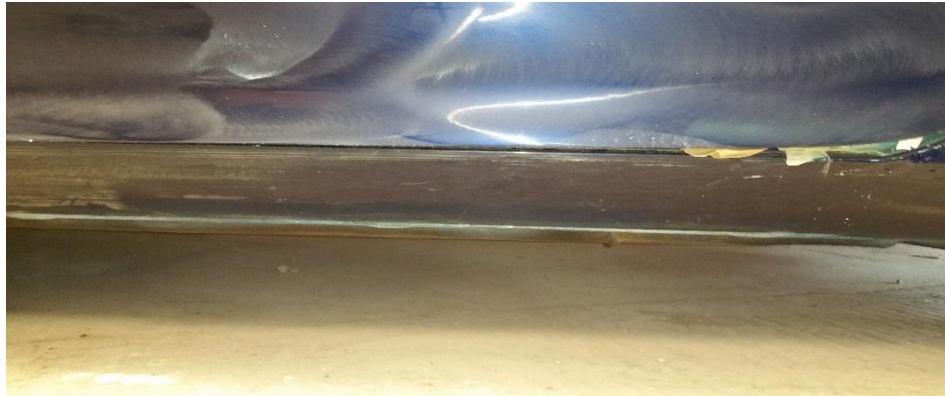
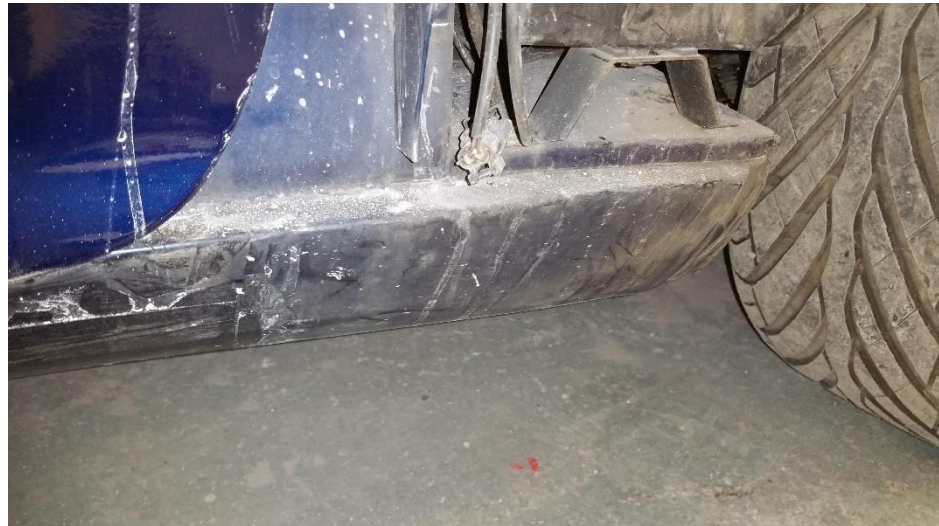
Having been warned about rust on these cars I was very pleased to find that there was no evidence of rust at all other than minor surface blemishes on some edges.

(Sill shots showing zero rust – pre Waxoyl).

When reassembling the car it was decided for longevity to use copious amounts of Waxoyl on “under” surfaces rather than aim for a concours paint finish.

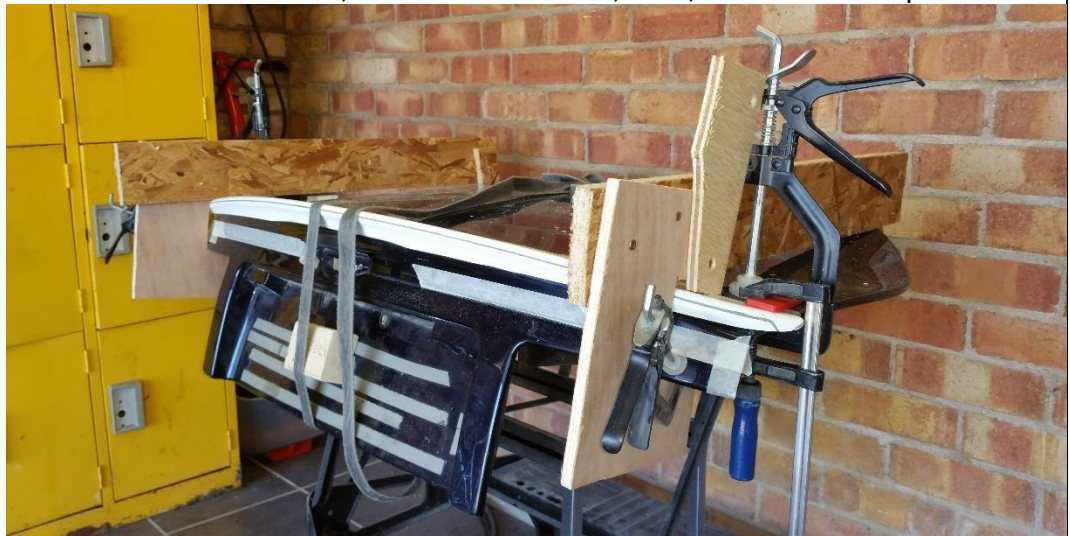
<p>the DB7.</p> <p><i>(Shows jig to reshape and twist pre-cut spoiler. New GRP core to hold shape).</i></p> <p>The spoiler is attached using high quality tape and so can be removed if desired.</p>
May 2016	40524	<p>The dipped main beam lights were converted to HID.</p> <p>All other exterior lights were replaced with LED lamps.</p>

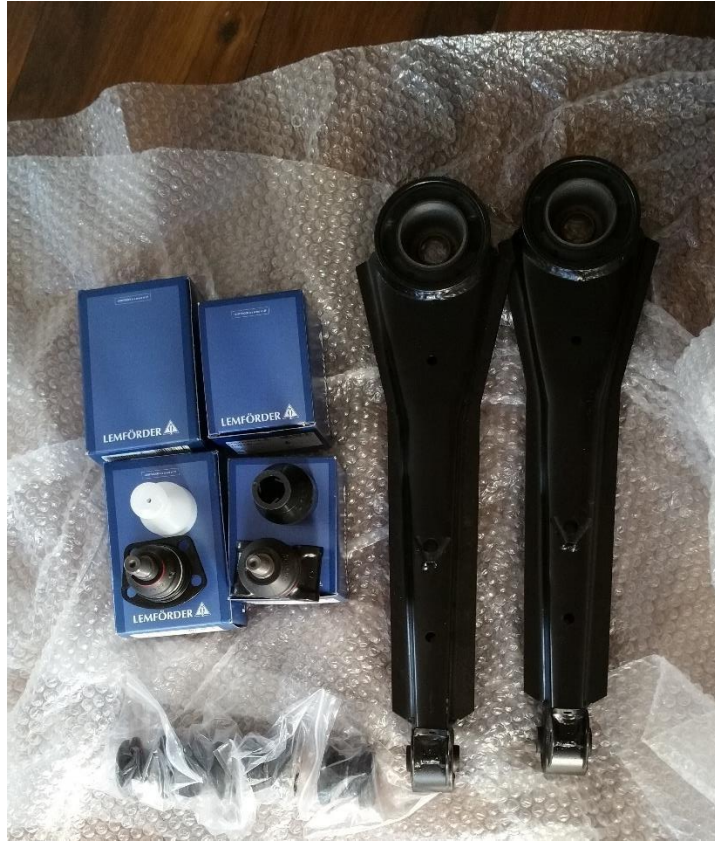
were some wiring changes which have been added to my printed workshop manual.
JanuaryFebruary 2018	42033	Suspension overhaul (Part 1) There were no issues at MOT, but the suspension all looked original, so 16 years old. I decided to start to renew parts to tighten up the ride/handling. Rear: Changed rear radius arms and bushes.

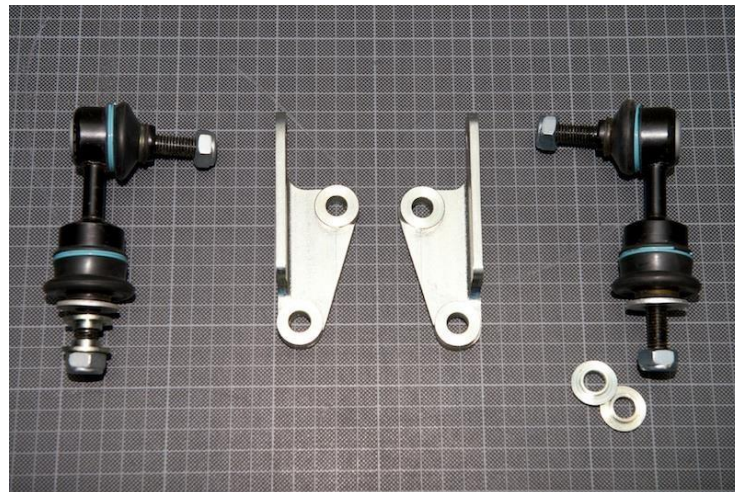
Front: Shock absorbers (inc new bushes) rebuilt by Bilstein in Leicester.
New top and bottom ball joints (Lemforder OEM spec).
New upper wishbone bushes.
New roll bar mounting bushes.

Upgraded roll bar drop links fitted.

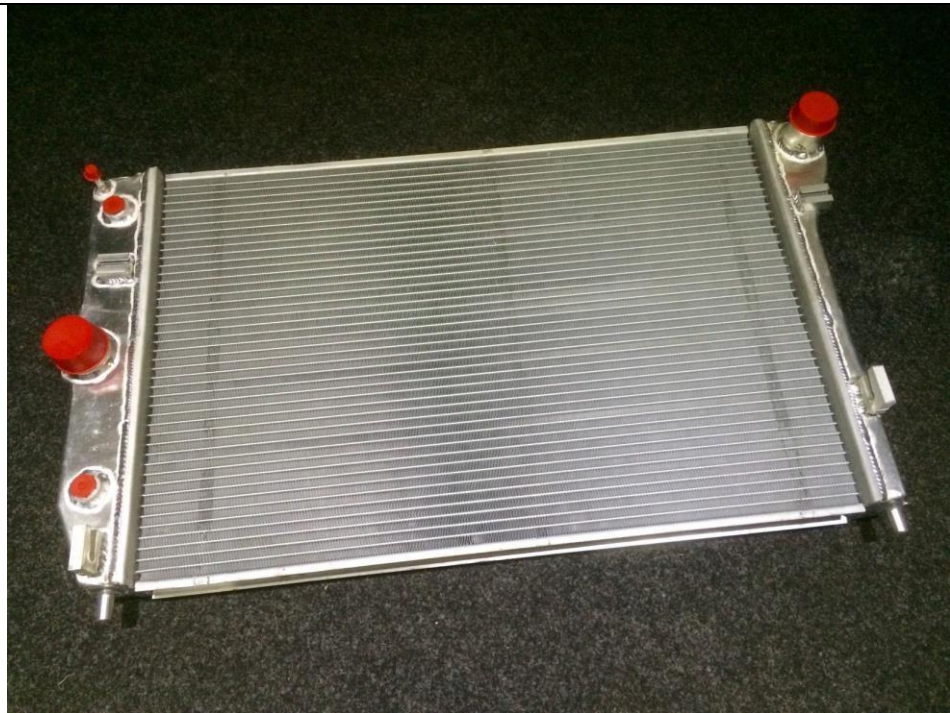
March 2018	42045	Following suspension overhaul had full front/rear tracking carried out (ATS).
May/June 2018	43008	After booking a precautionary auto gearbox fluid and filter change water was found in the gearbox oil. This was due to a small leak in the main radiator heat exchanger with big consequences. 1. New Radiator required.

(Please note, that I forgot to photograph the new rad before installing it so this isn't the actual unit – but is identical)

The new AML radiator features the updated/upgraded all aluminium design and a full system flush was carried out prior to fitting. 50/50 OAT and softened water used to refill.
