Extra Service/Repair/Upgrade :

This is separate and additional to the scheduled normal servicing – records of this are also kept.

OWNER: Brendan Cunningham

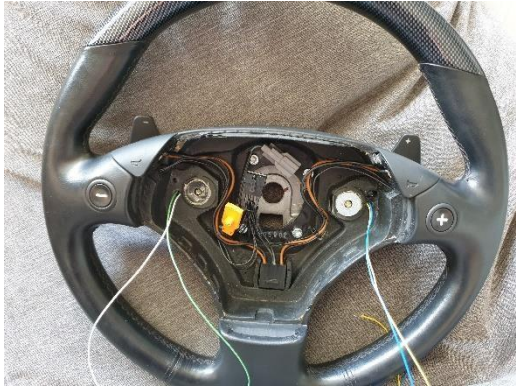
June 2021	44254

Steering wheel paddle shift. The push buttons are just not nice to use so I set about grafting paddle shifters onto the DB7 steering wheel.
July 2021	44401

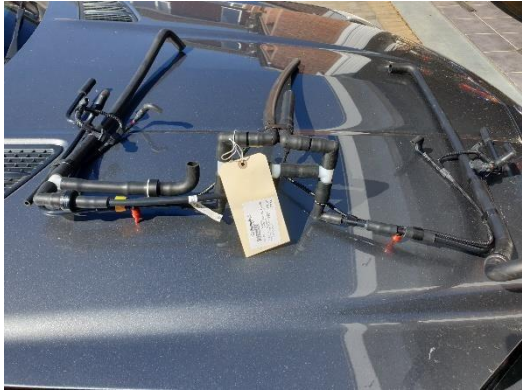
Following some intermittent OBD error codes and the well documented issues with the complex engine breather system I decided to invest in a complete new assembly (a lot of money for mostly rubber pipe!). Also replaced air filters with permanent oiled units from Four Ashes Garage.
July 2021	44589		The primitive gear display in the DB7 instrument cluster was not compatible with the new transmission control module. The original display shows "A" unless in manual mode when it shows "12345". The new display shows "PRN123456" as well as an extra LED to show when "sport mode" is engaged.
